**Flood Control Project Maintenance  
Levee Inspections**  
**LMA District Cover Sheet**  
**Spring 2018 Levee Inspection Results**

**Reclamation District No. 0900 West Sacramento**

**Spring 2018 Levee Inspection Results**

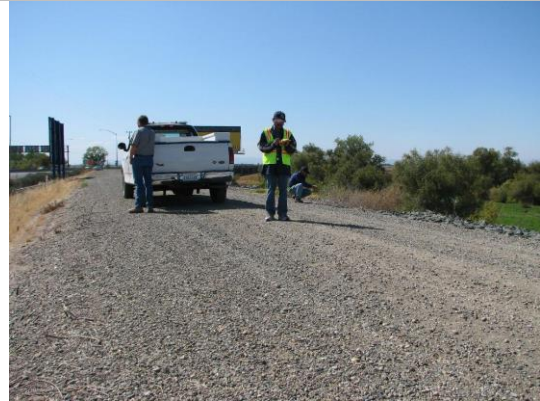
Photo 1 of 3 : UCIP\_SP\_2018\_41826\_72722.jpg

FS\_ID:41826  
DS\_ID:17874  
EP\_NO: 17739  
Repair Type: Non-Urgent  
Crossing Status: Indicator Found  
UCIP Comments: Records show 3 gas lines in general area--unable to confirm alignment and status of crossing. Markers visible in general area are for Kinder Morgan and not the owner listed on permit. Need to contact owner to clarify if crossing is still present and if so determine status of crossing. Need date of last inspection and confirmation that crossing is still in operable condition.  
FIELD\_STRUCT\_DESC: 20-inch petroleum pipeline across and under (bored) Willow Slough and its west levee, across (trenched) the Yolo bypass, and across and under (bored) toe drain and east levee. (20-inch pipe authorized under Permit No. 17739, 2004 - Paragon Partners Ltd.; name change authorized under Permit No. 17739-Rev, 2004 - SFPP, L.P., a Delaware Limited Partnership c/o Paragon Partners Ltd)  
FS Date: 10/5/2009

View of levee crown near marker.

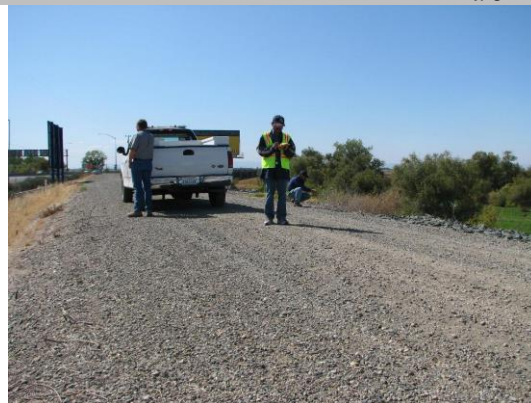
Photo 1 of 3 : UCIP\_SP\_2018\_41824\_72728.jpg

Comment Code					
Inspector Comment					
FS_ID:41824 DS_ID:17861 EP_NO: 11539 Repair Type: Non-Urgent Crossing Status: Indicator Found UCIP Comments: Records show 3 gas lines in general area--unable to confirm alignment and status of crossing. Markers visible in general area are for Kinder Morgan and not the owner listed on permit. Need to contact owner to clarify if crossing is still present and if so determine status of crossing. Need date of last inspection and confirmation that crossing is still in operable condition. FIELD_STRUCT_DESC: 16-inch steel gas line through the levee, 3.5 feet below the levee crown. (16-inch pipe authorized under Permit No. 11539, 1977 - Pacific Gas and Electric Company [PG&E]). [Additional Reference(s): DWR Levee Log, 2003] FS Date: 10/5/2009

View of levee crown near marker visible on landward shoulder.

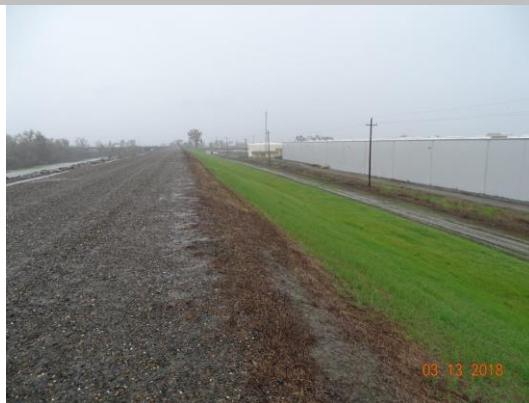
Photo 1 of 1 : SP\_2018\_RD0900\_231\_17\_20180314\_00050.jpg

LM Start	1.30	Rating **	A	Issue No.	17
LM End	1.30	Issue Type +	Ma	Location *	LS
Category	Earthen Levee			GPS Latitude/Longitude	
				Start	End
Item	Vegetation			38.569404 °	38.569404 °
				-121.582193 °	-121.582193 °
DWR ID	DWR_RD0900_02_s_2018_17				
Comment Code					
V1 : Control annual grass and weeds on the levee slopes and easements.					
Inspector Comment					
LMA is doing a good job with vegetation control.

Good vegetation control landside looking north.

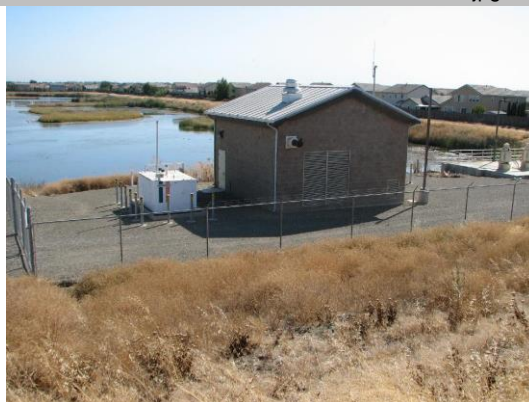
Photo 3 of 3 : UCIP\_SP\_2018\_37780\_68660.jpg

Structure located next to pump station visible on landward side.

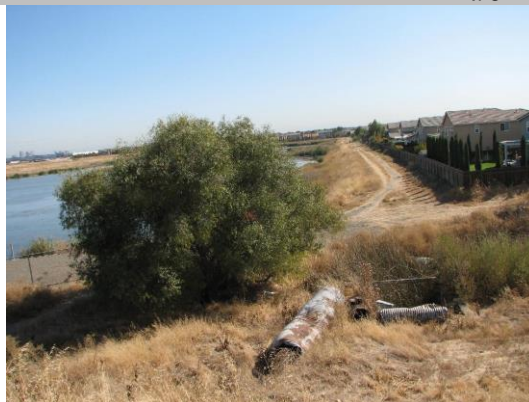
Photo 1 of 3 : UCIP\_SP\_2018\_37785\_68693.jpg

Comment Code					
Inspector Comment					
FS_ID:37785					
DS_ID:17856					
EP_NO: 2721A					
Repair Type: Non-Urgent					
Crossing Status: Found					
UCIP Comments: Need to contact owner--crossing appears to no longer be in use. Abandoned pipe sections visible on landward side and damage to pump station on waterward side.					
FIELD_STRUCT_DESC: [Drainage Pump Station] 36-inch corrugated metal irrigation pipe through the levee, 3.0 feet below the levee crown. Pump house and siphon breaker are located on the on the waterside (WS). (two 30-inch pipes at location 1, HLM 1.05, (drainage pump) and 36-inch pipe at location 2, HLM 3.68, (irrigation pump) authorized under Permit No. 2721A - Reclamation District No. 900 [RD0900]). [Additional Reference(s): DWR Levee Log, 2003]					
FS Date: 10/5/2009

View of pipe sections visible on landward side.

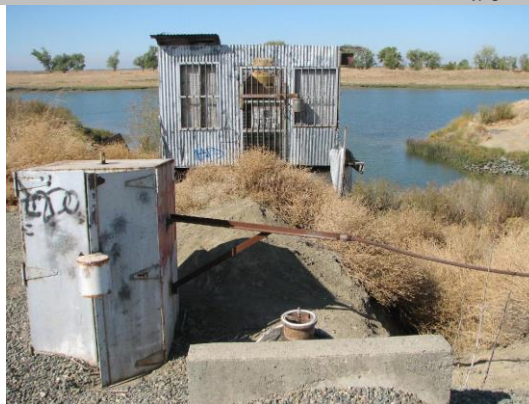
Photo 3 of 3 : UCIP\_SP\_2018\_37785\_68691.jpg

View of pump house visible on waterward side.

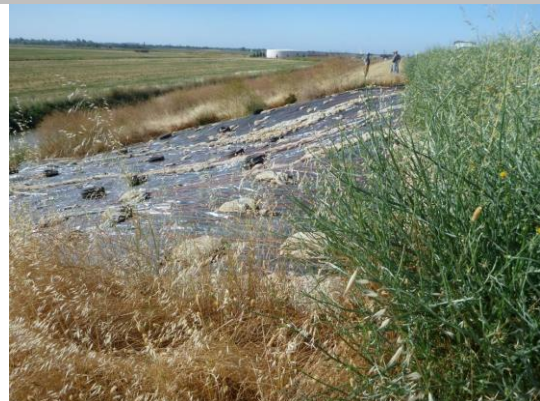
Photo 1 of 7 : LEVAL\_SP\_2018\_198\_189.jpg

Comment Code					
Inspector Comment					
Levee Evaluation Comments					
Description:					
Site ID No:198					
Site Designation:RD 900-01					
Repair Type: Erosion					
Rating:Serious					
Field Date:6/6/2017					
Notes: LS, thorny vegetation is present at levee toe/canal. Light grass present along LS slope. Primary use of canal is for drainage, ranges in width 15-25; on average 20ft. RD rep. mentioned permitting has begun to replace drainage canal with 32in pipe for storm drainage to community. 8,600 LF of the LS levee has sloughing of the LS toe access road into drainage canal. There is no imminent threat of losing levee in next storm event. DWR inspector: LMA repaired two landside erosion sites (levee mile 5.26 and 4.63) during fall 2017 inspection.

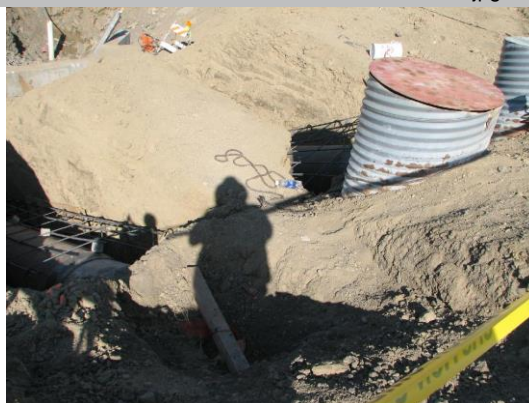
Photo 2 of 3 : UCIP\_SP\_2018\_37890\_68940.jpg

Construction of structures in Oct-2009, photo 2 of 3.

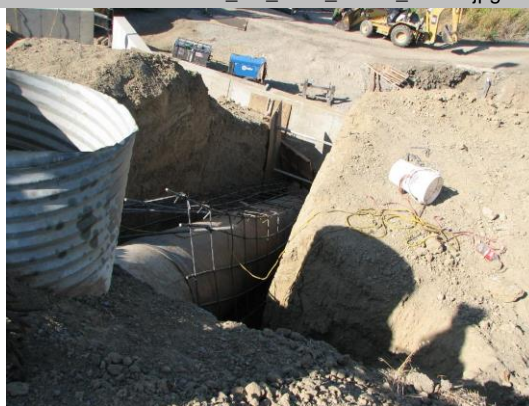
Photo 3 of 3 : UCIP\_SP\_2018\_37892\_68945.jpg

Comment Code						
Inspector Comment						
FS_ID:37892						
DS_ID:17882						
EP_NO: 18116						
Repair Type: Non-Urgent						
Crossing Status: Found						
UCIP Comments: Under construction Oct-2009. Need updated photos of completed structure.						
FIELD_STRUCT_DESC: [West Sacramento Main Darin Pump Station]						
3 of 4. 54-inch steel drainage pipe through the levee, 12.9 feet below the crown. Pump house is located on the landside (LS) and siphon breaker is located on the waterside (WS) slope. (four 54-inch pipes authorized under Permit No. 18116, 2007 - Reclamation District No. 900 [RD0900]; existing dual 48-inch pipes (60-inch pipes referenced in permit) removed; dual 48-inch pipes authorized under Permit No. 4257, 4257-A, 1963 - RD0900) [Additional Reference(s): DWR Levee Log, 2003]						
FS Date: 10/5/2009

Construction of structures in Oct-2009, photo 3 of 3.

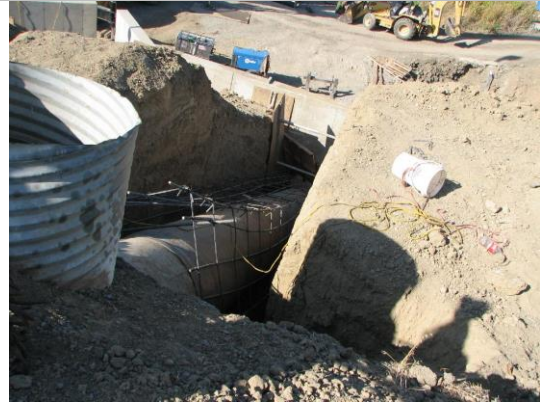
Photo 3 of 3 : UCIP\_SP\_2018\_37894\_68951.jpg

Comment Code						
Inspector Comment						
FS_ID:37894 DS_ID:17883 EP_NO: 18116 Repair Type: Non-Urgent Crossing Status: Found UCIP Comments: Under construction Oct-2009. Need updated photos of completed structure. FIELD_STRUCT_DESC: [West Sacramento Main Darin Pump Station] 4 of 4. 54-inch steel drainage pipe through the levee, 12.9 feet below the crown. Pump house is located on the landside (LS) and siphon breaker is located on the waterside (WS) slope. (four 54-inch pipes authorized under Permit No. 18116, 2007 - Reclamation District No. 900 [RD0900]; existing dual 48-inch pipes (60-inch pipes referenced in permit) removed; dual 48-inch pipes authorized under Permit No. 4257, 4257-A, 1963 - RD0900) [Additional Reference(s): DWR Levee Log, 2003] FS Date: 10/5/2009

Construction of structures in Oct-2009, photo 3 of 3.
